RESOURCE CONSERVATION AND RECOVERY ACT SITE INSPECTION REPORT  
ADDENDUM INTERIM REMOVAL ACTION FOR UNEXPLODED ORDNANCE 8  
PYROTECHNICS AREA OUTSIDE TEST BURN PADS NSA CRANE IN  
11/1/2011  
TETRA TECH

## **Site Inspection Report Addendum Interim Removal Action UXO 8 - Pyrotechnics Area Outside Test Burn Pads**

### **Naval Support Activity Crane Crane, Indiana**

**November 2011**

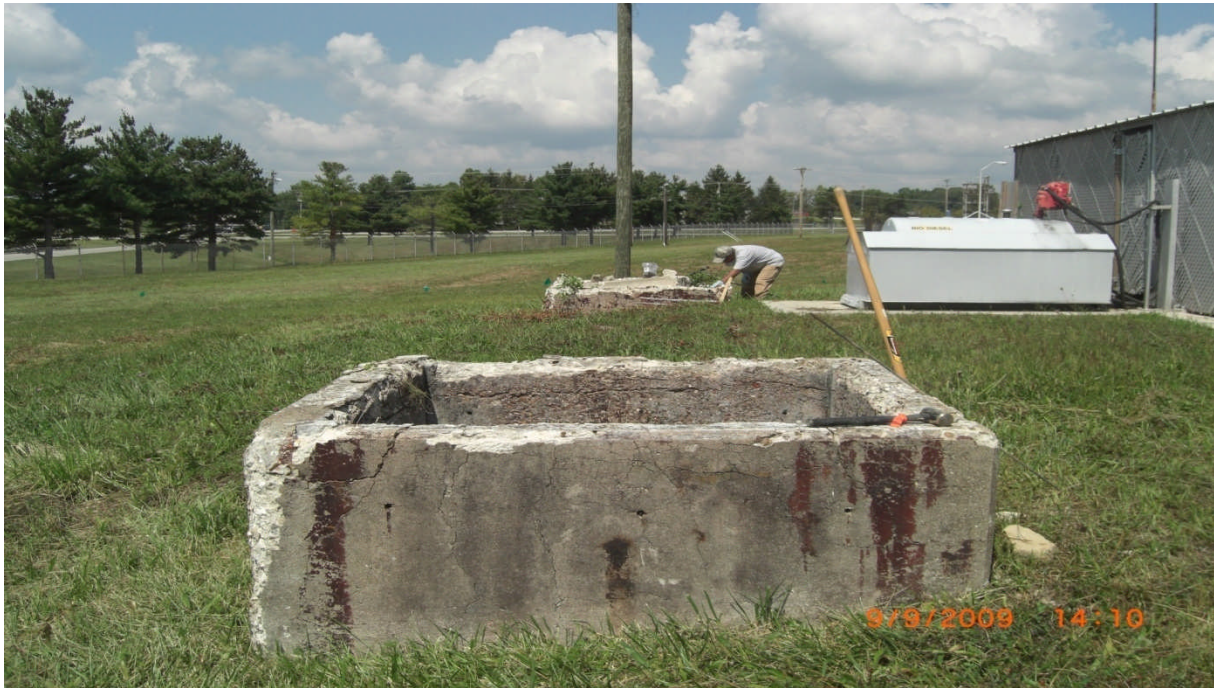
1  
9/9/2009

**DESCRIPTION:** General view of the two concrete basins.

The purpose of this SI Addendum is to report the field activities associated with removal of the two concrete test basins located within the Pyrotechnics Area at NSA Crane ([Photographs 1](#) and [2](#)). Based on the SI results, the concrete test basins appeared to be intact with solid concrete bottoms; therefore, the residual materials within the basins would not have any impact on the area outside of the basins. The SI Report recommended removal and proper disposal of residual material in the concrete basins followed by demolition and removal of the concrete basin structures. These recommendations were approved by both the Navy on August 6, 2010, and the Indiana Department of Environmental Management (IDEM) on September 9, 2010.

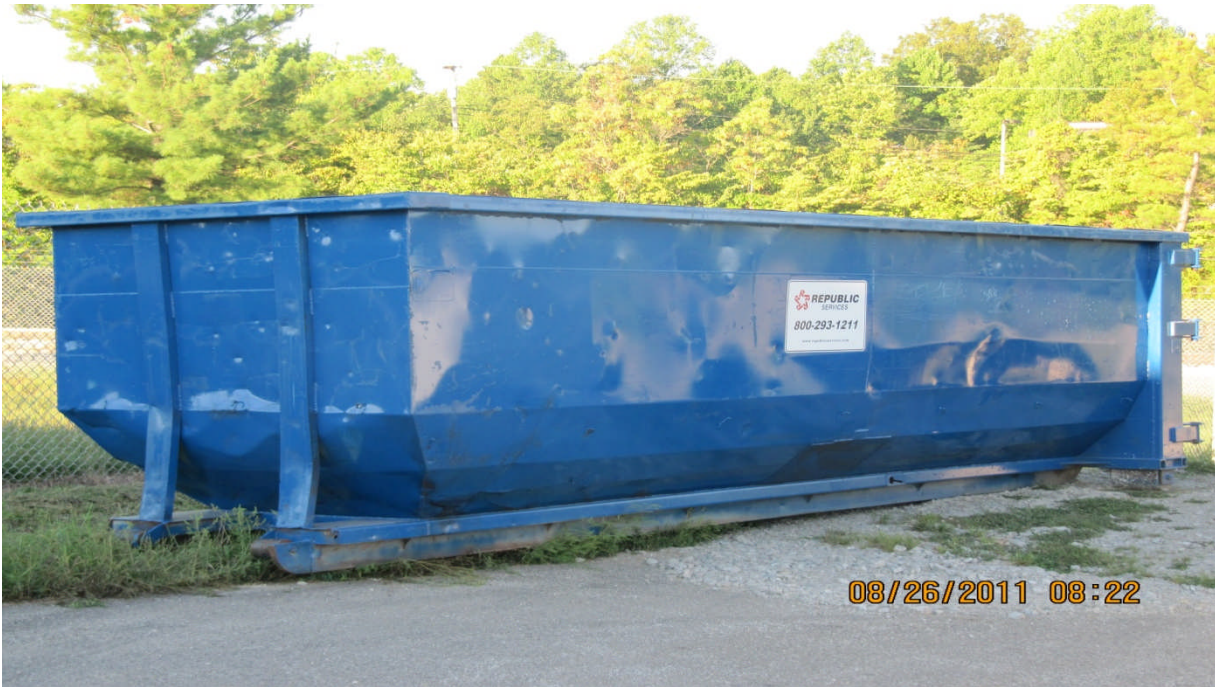
3  
8/26/2011

**DESCRIPTION:** Roll-off utilized for temporary on-site storage  
of concrete debris.

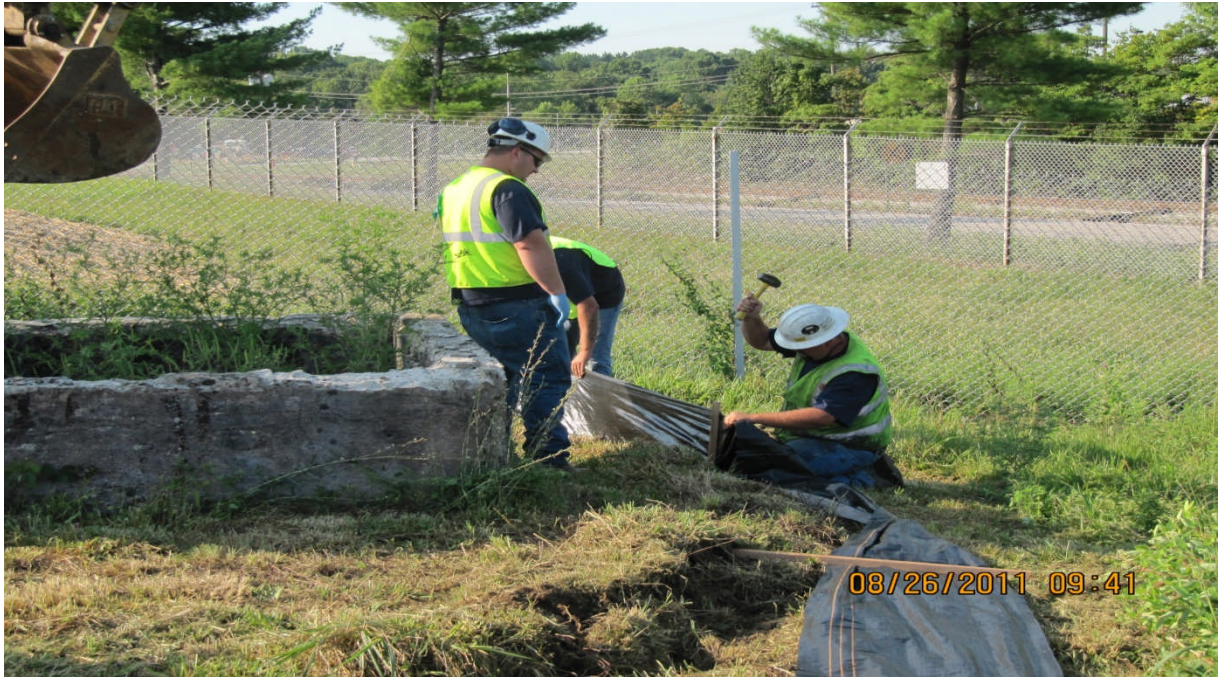
5  
8/26/2011

**DESCRIPTION:** Installation of the silt fence down slope of the test basins.

To ensure no run-off from the disturbed area would affect the surrounding environment, Micah installed silt fencing down slope of each of the two concrete test basins ([Photograph 5](#)).

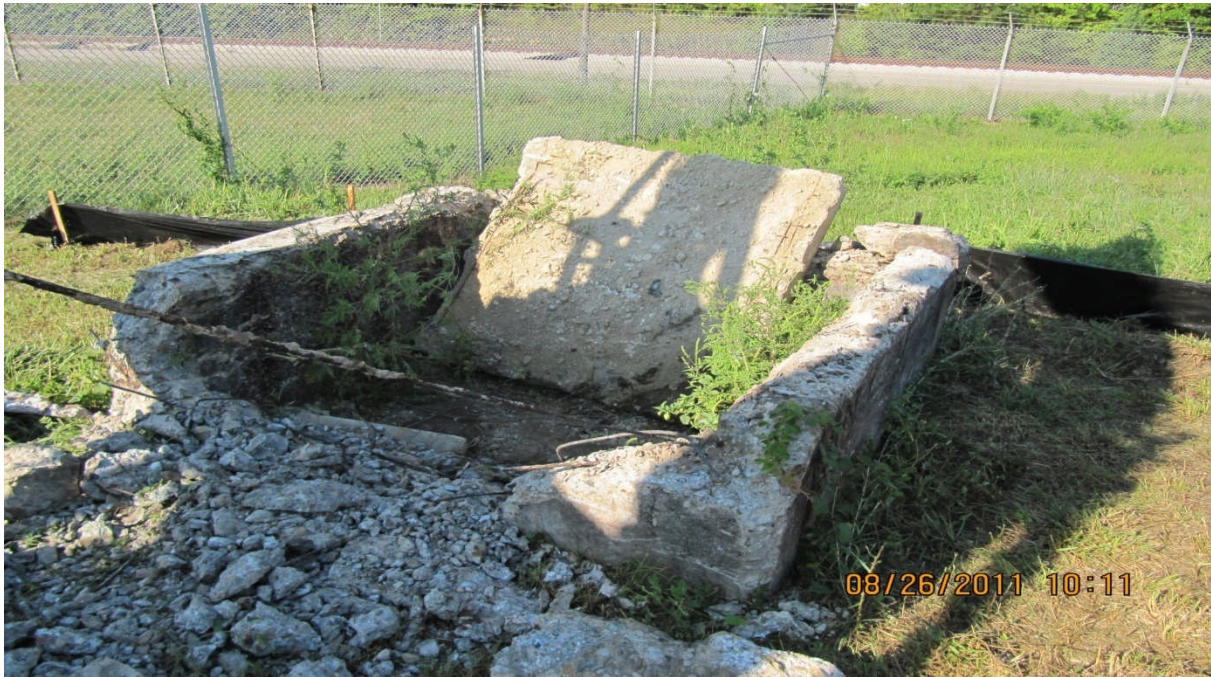
7  
8/26/2011

**DESCRIPTION:** Large piece of concrete located in the southern test basin.

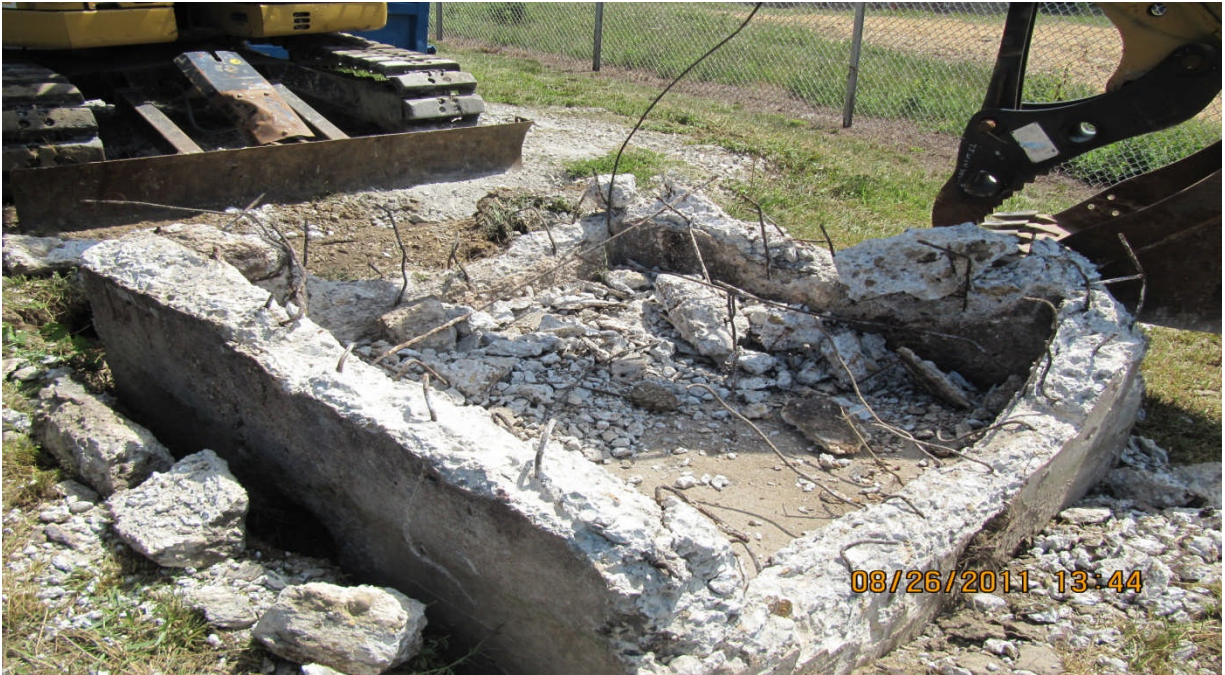
9  
8/26/2011

**DESCRIPTION:** Removal of the southern test basin.

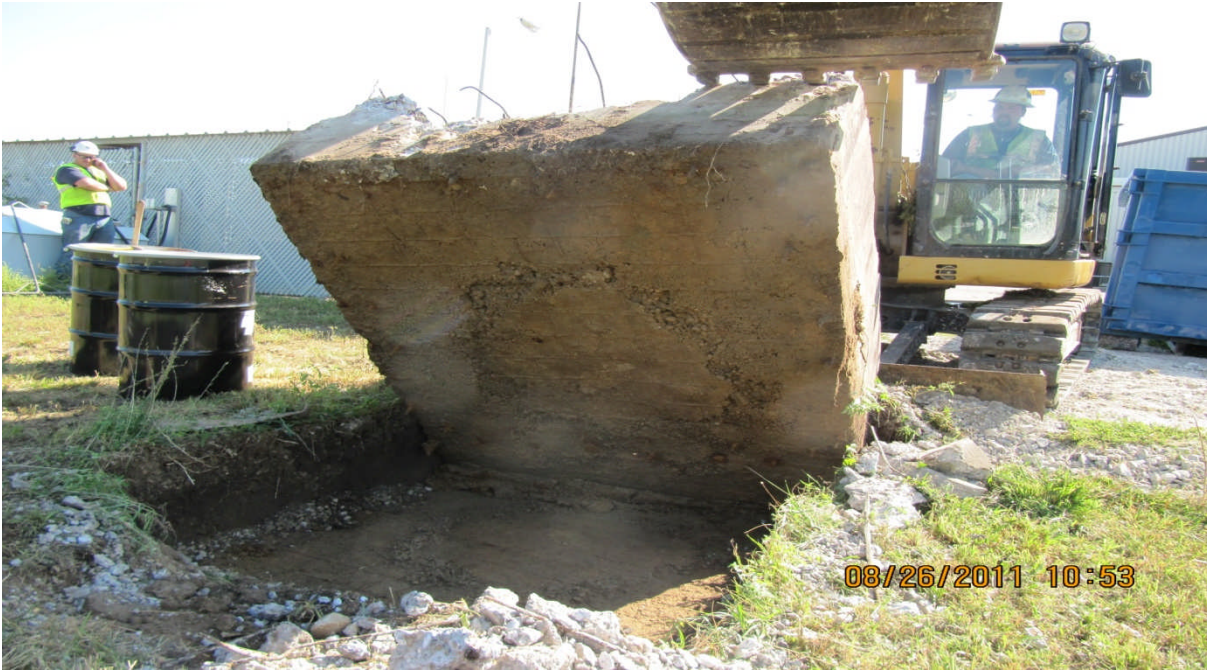
11  
8/26/2011

**DESCRIPTION:** View showing the intact bottom of the  
southern test basin.

- The bottoms of the concrete basins were confirmed to be intact, and during demolition, it was observed that the basin walls and base contained extensive metal reinforcement.

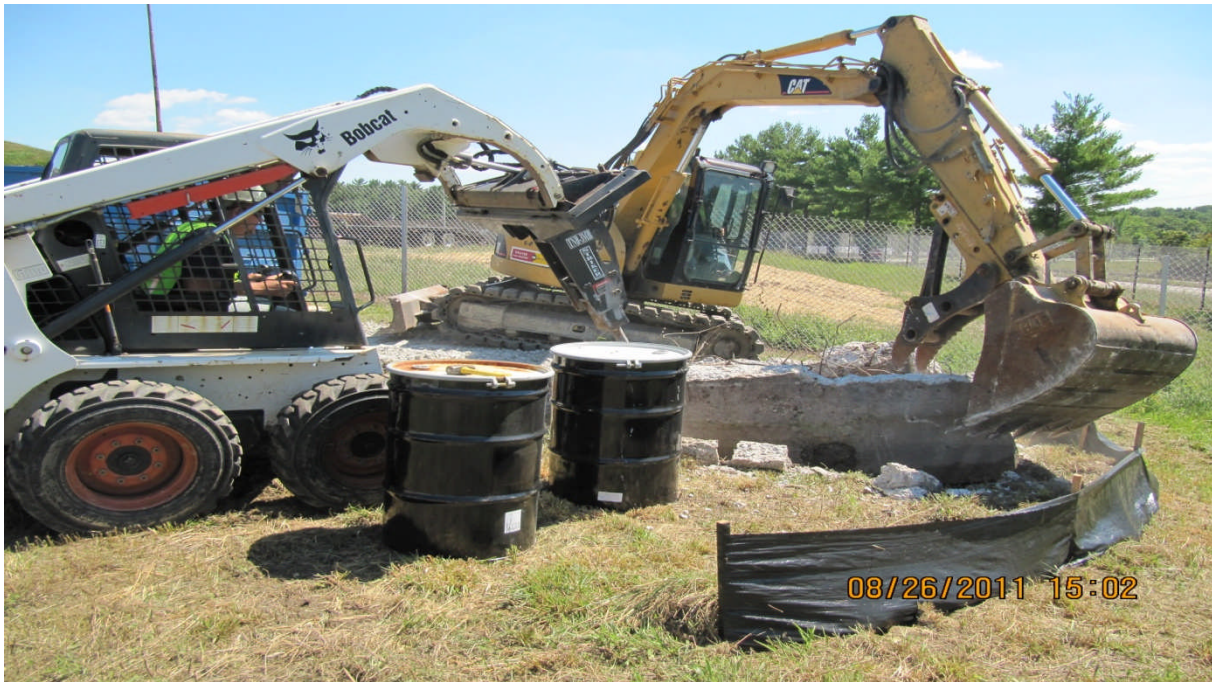
13  
8/26/2011

**DESCRIPTION:** Bobcat with hydraulic breaker and backhoe  
working together to remove the southern basin.

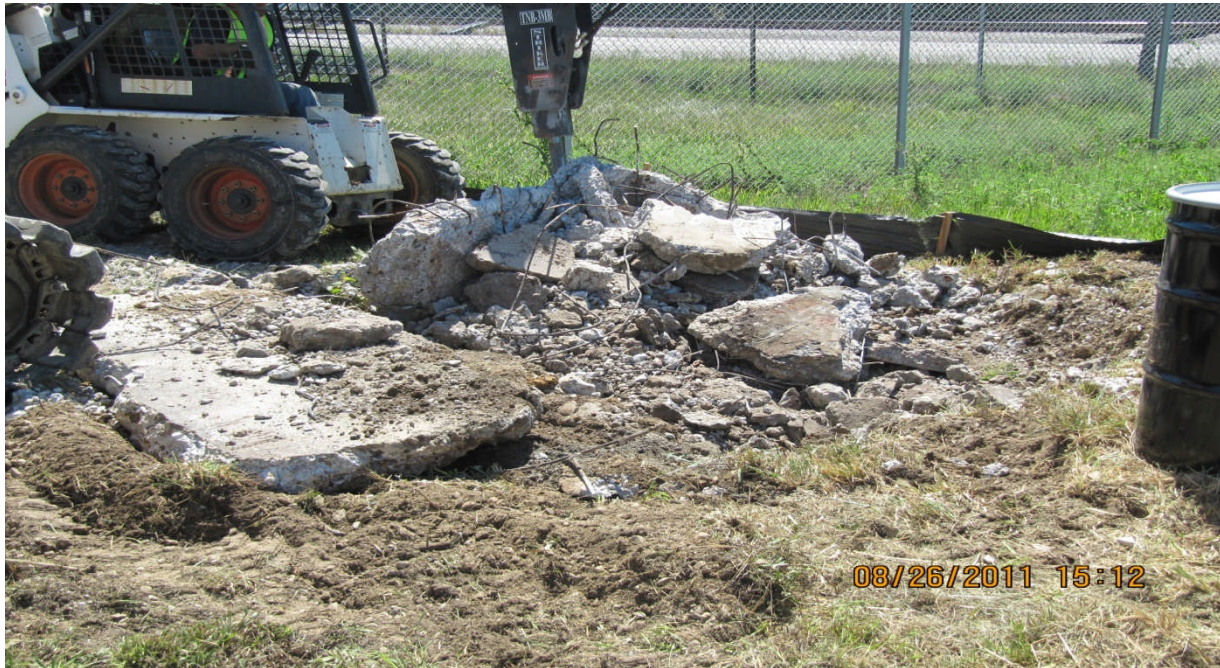
15  
8/26/2011

**DESCRIPTION:** Cleanup of the southern test basin.

Micah began to demolish the bottom of the basin. This proved more difficult than anticipated because the concrete was approximately 8 inches thick and contained extensive rebar ([Photographs 11](#) and [12](#)). Since the basin floor was too large to place into the roll-off box, a Bobcat with a hydraulic breaker attachment (jackhammer) was used to break up the concrete ([Photographs 13, 14, and 15](#)). [Photograph 11](#) provides a view of the bottom of the basin floor, which was completely intact. By using the jackhammer attachment, Micah was able to break up the concrete basin floor into manageable pieces, which were then placed into the roll-off box ([Photograph 15](#)).

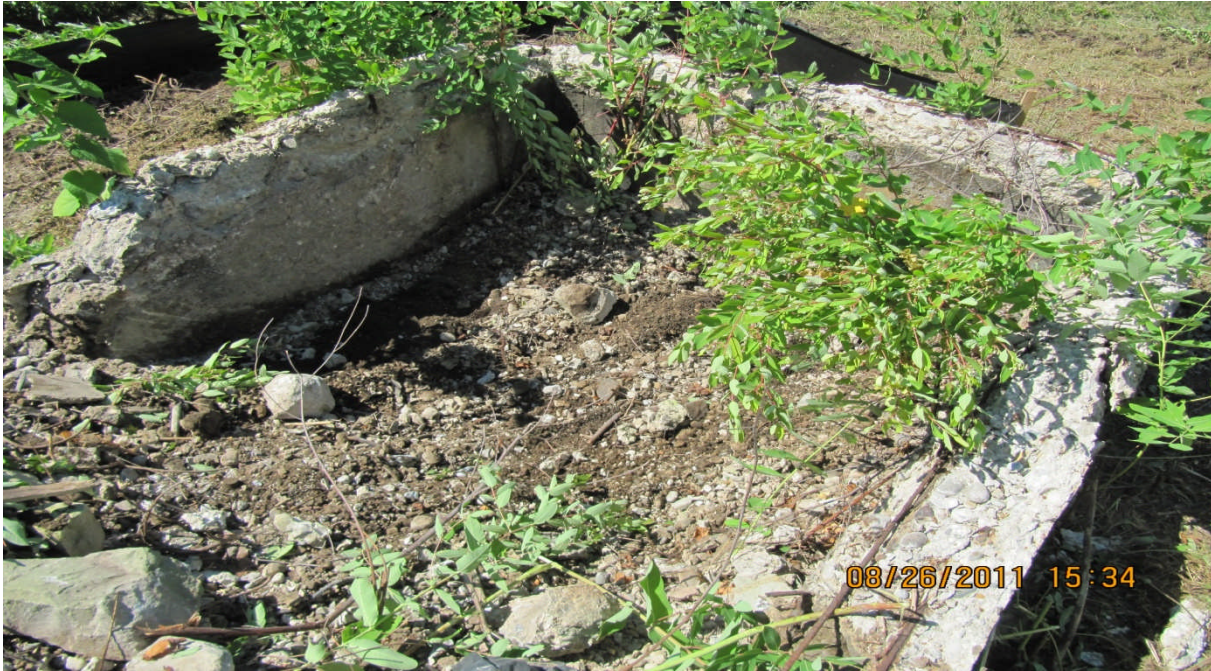
17  
8/26/2011

**DESCRIPTION:** Residual material located within the northern test basin.

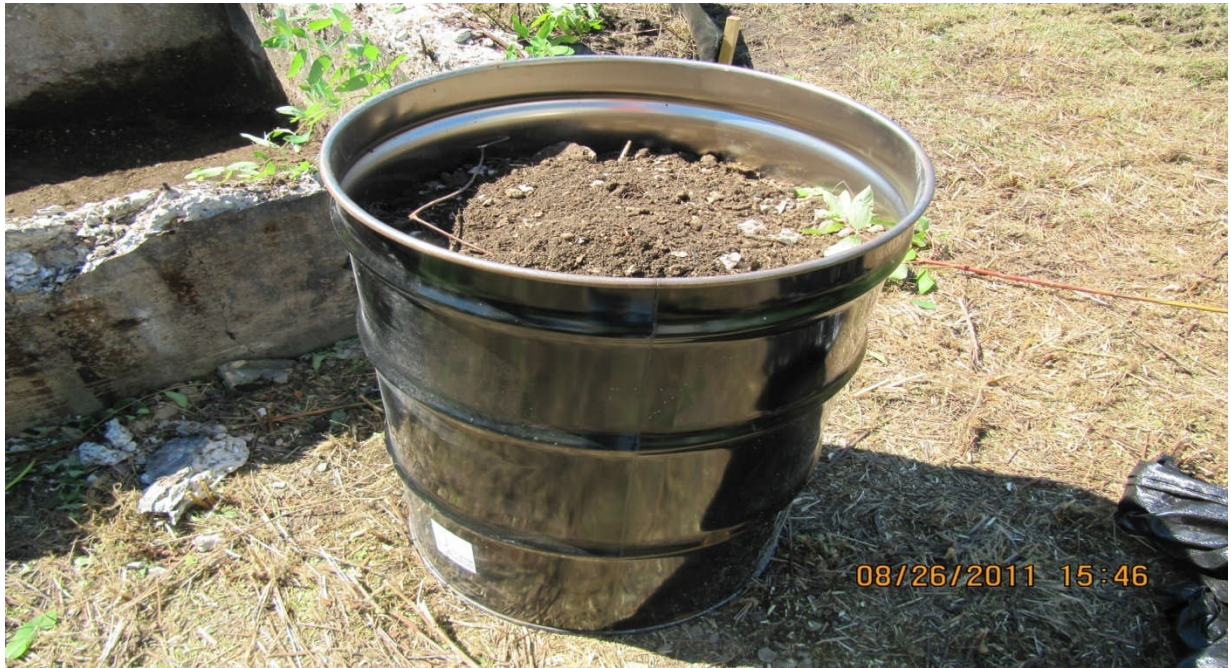
19  
8/26/2011

**DESCRIPTION:** Residual material removed from the northern  
test basin and collected in 55-gallon drum.

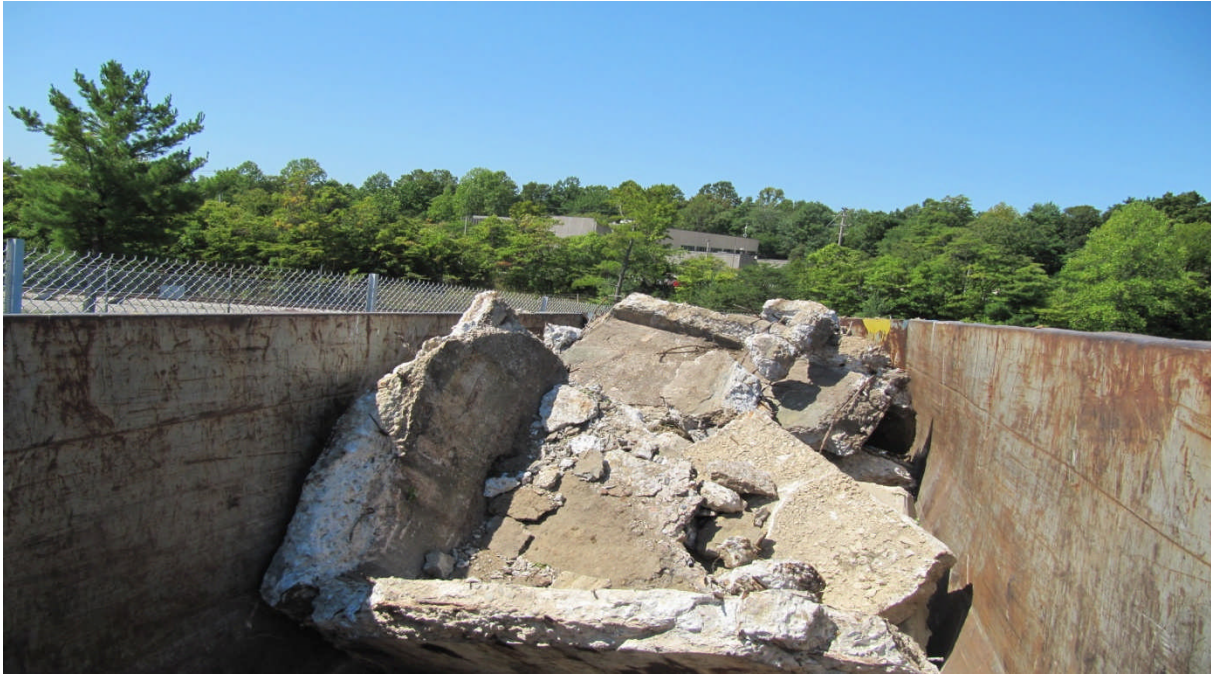
21  
8/26/2011

**DESCRIPTION:** Concrete debris from test basins placed in staged roll-off box.

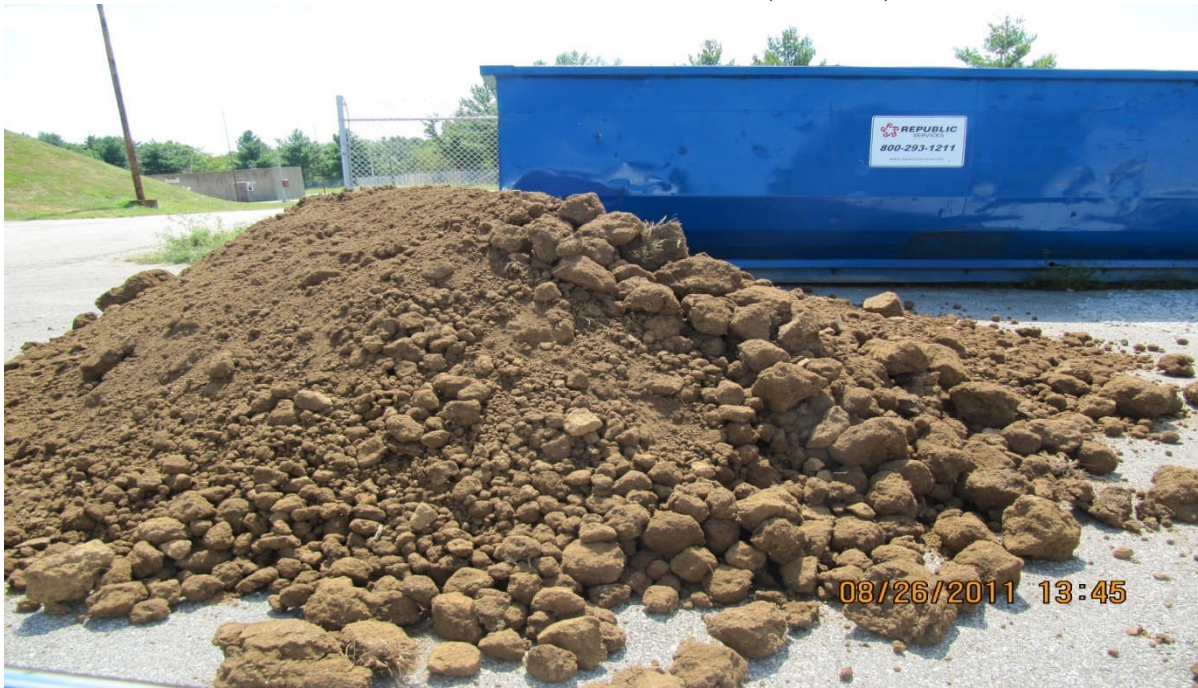
23  
8/26/2011

**DESCRIPTION:** Clean backfill material.

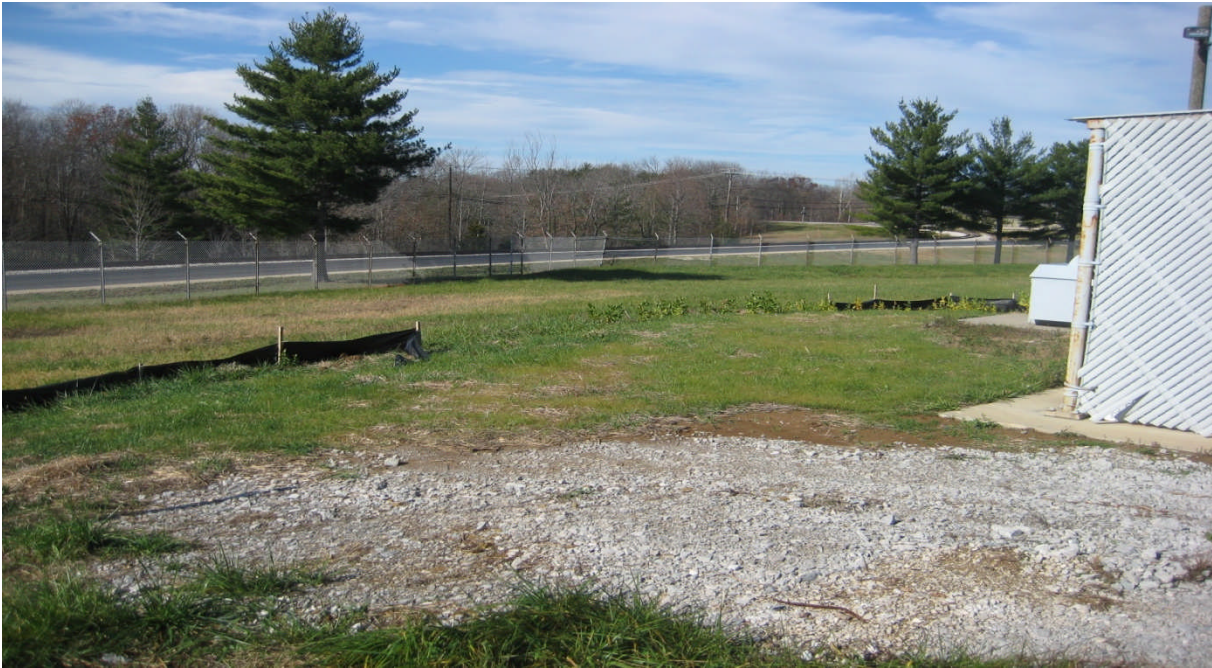
25  
11/16/2011

**DESCRIPTION:** Overall view of the disturbed area after  
grass seed germination.

An inspection of the area on November 16, 2011 indicated the grass seeding effort was successful (Photographs 25 and 26). Runoff is no longer a concern at the site and the silt fences are proposed for removal during December 2011.
